**MASSACHUSETTS COASTAL BASIN  
GLOUCESTER, MASSACHUSETTS**

**WEST POND OUTLET  
MA 00186**

# **PHASE I INSPECTION REPORT NATIONAL DAM INSPECTION PROGRAM**

**DECEMBER 1979**

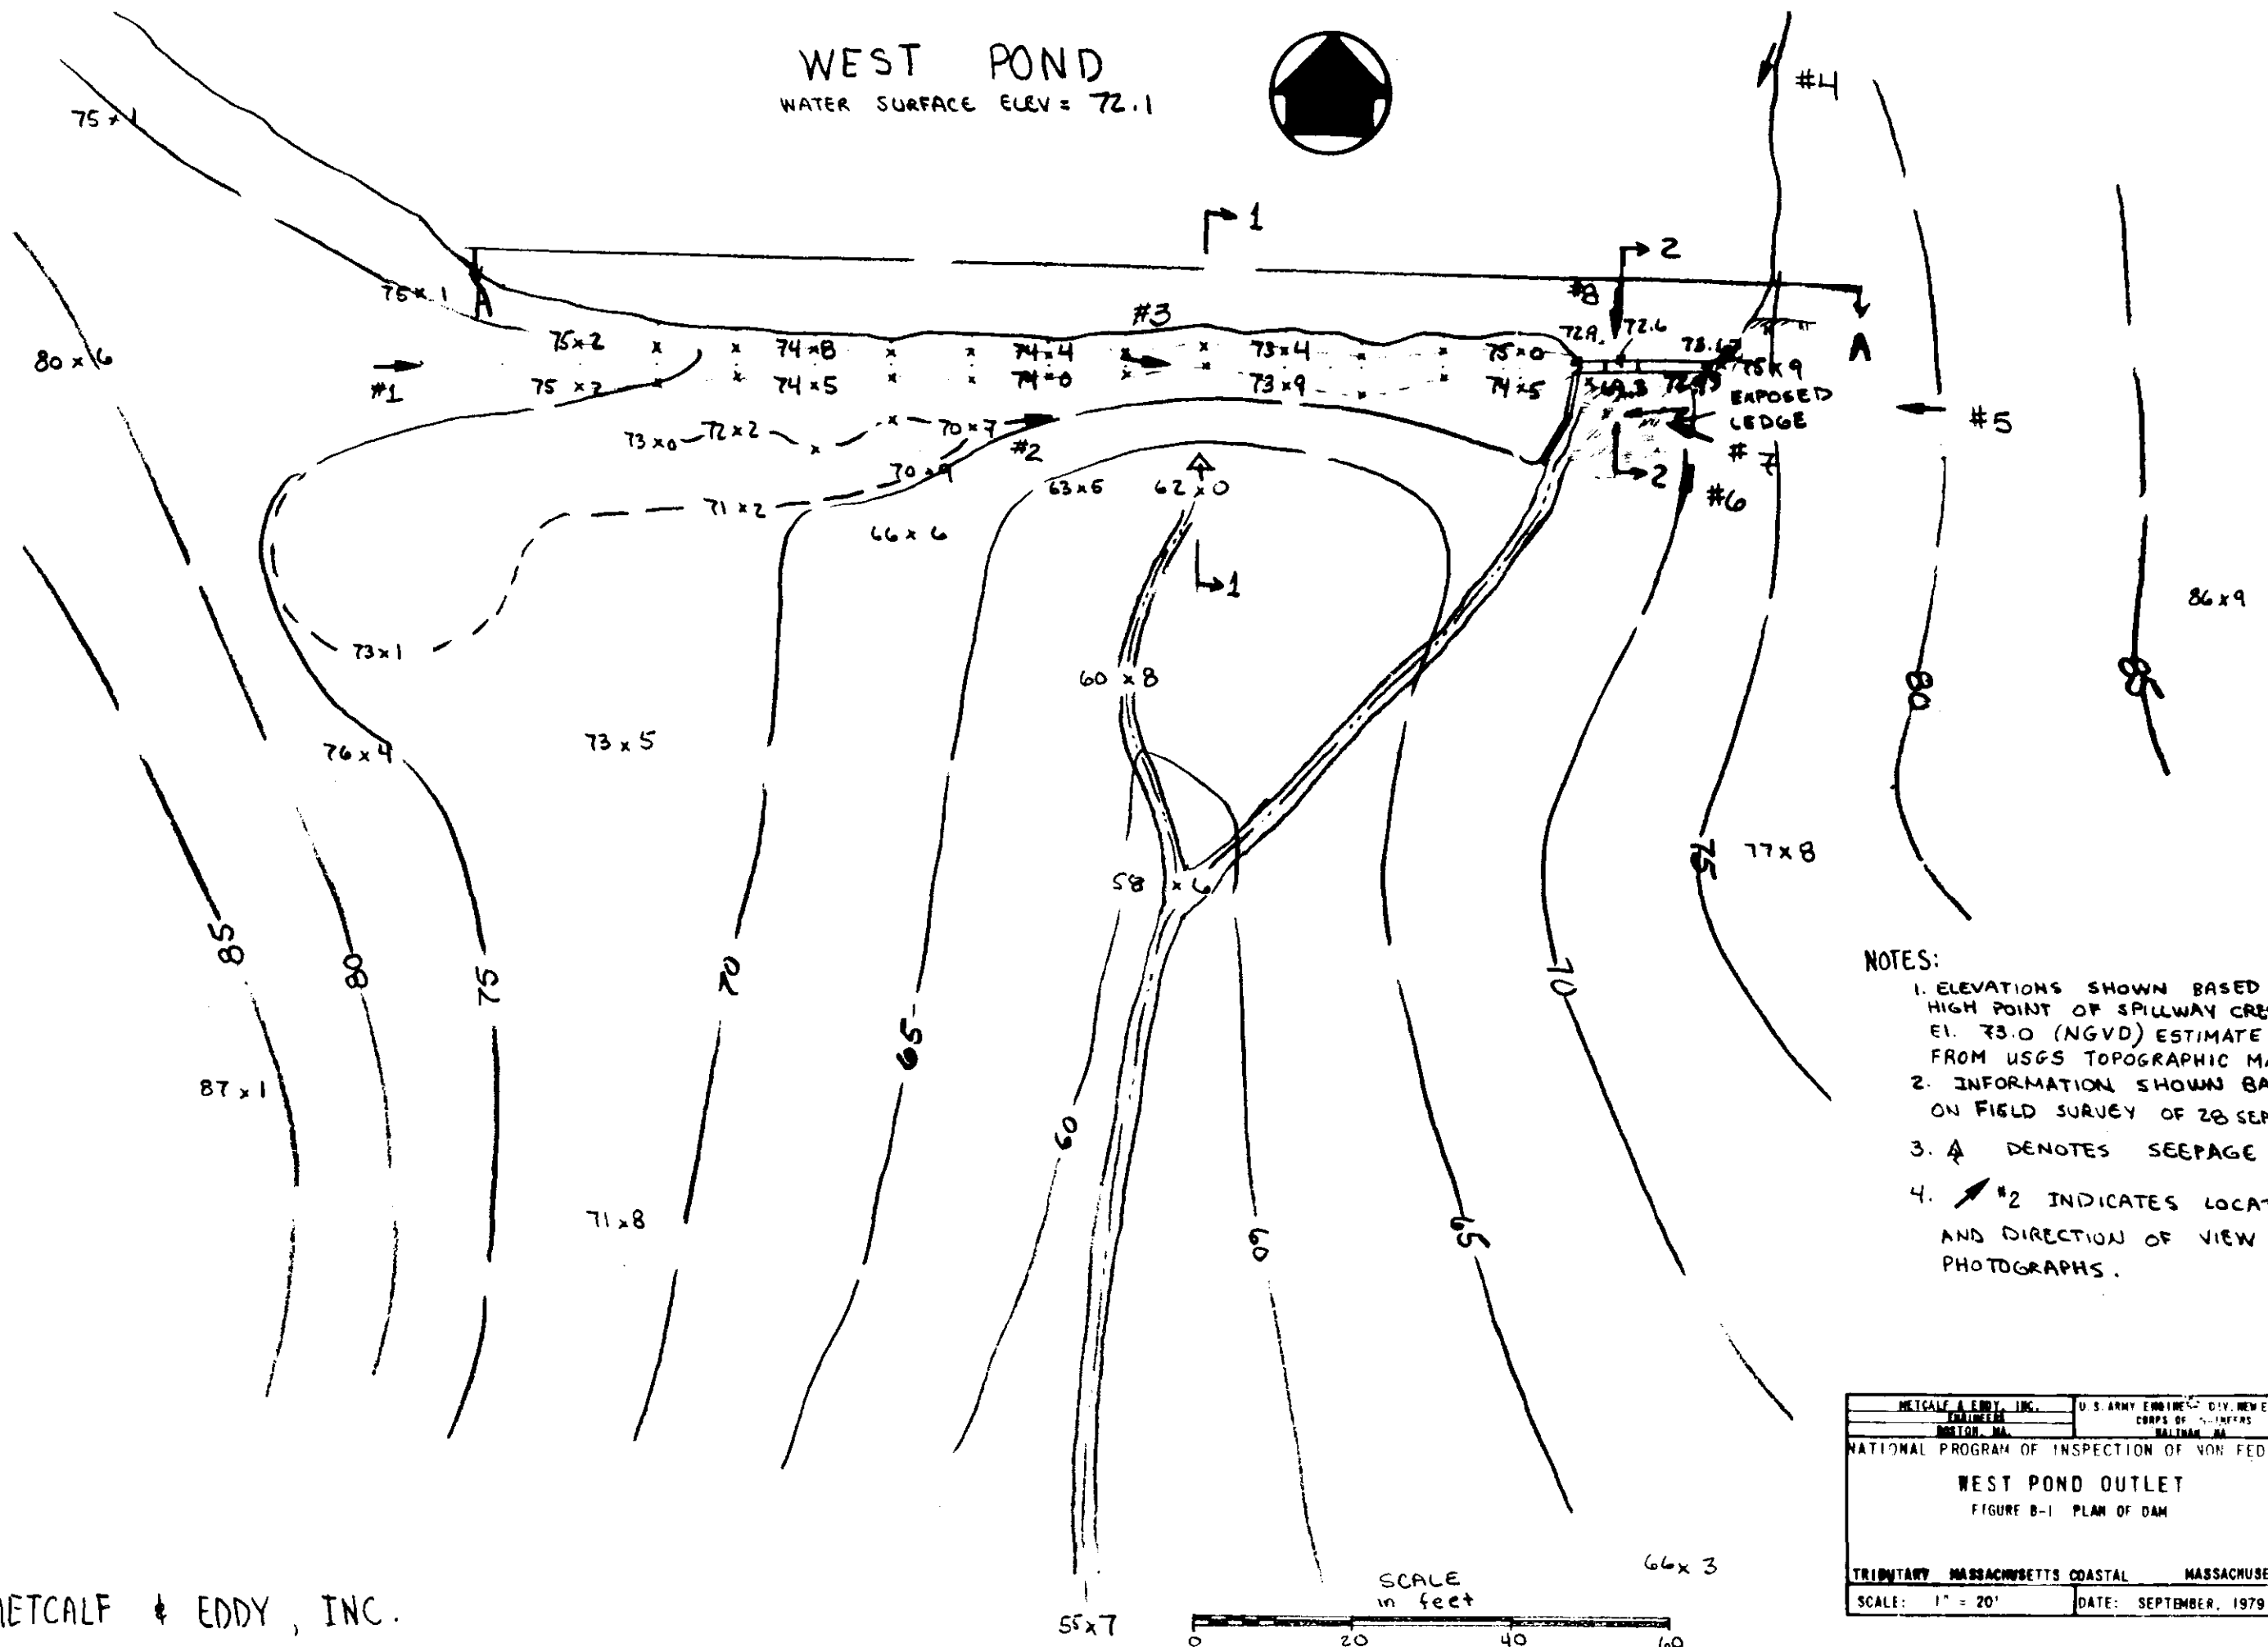
METCALF & EDDY, INC. BOSTON, MA.	U.S. ARMY ENGINEER DIV. NEW ENGLAND CORPS OF ENGINEERS BALTIMORE, MD.
NATIONAL PROGRAM OF INSPECTION OF NON-FED. DAMS	
WEST POND OUTLET FIGURE B-1 PLAN OF DAM	
TRIBUTARY MASSACHUSETTS COASTAL	MASSACHUSETTS
SCALE: 1" = 20'	DATE: SEPTEMBER, 1979

- NOTES:
1. ELEVATIONS SHOWN BASED ON HIGH POINT OF SPILLWAY CREST EL. 73.0 (NGVD) ESTIMATED FROM USGS TOPOGRAPHIC MAP.
  2. INFORMATION SHOWN BASED ON FIELD SURVEY OF 28 SEPT. 1979
  3. # DENOTES SEEPAGE
  4. #2 INDICATES LOCATION AND DIRECTION OF VIEW FOR PHOTOGRAPHS.

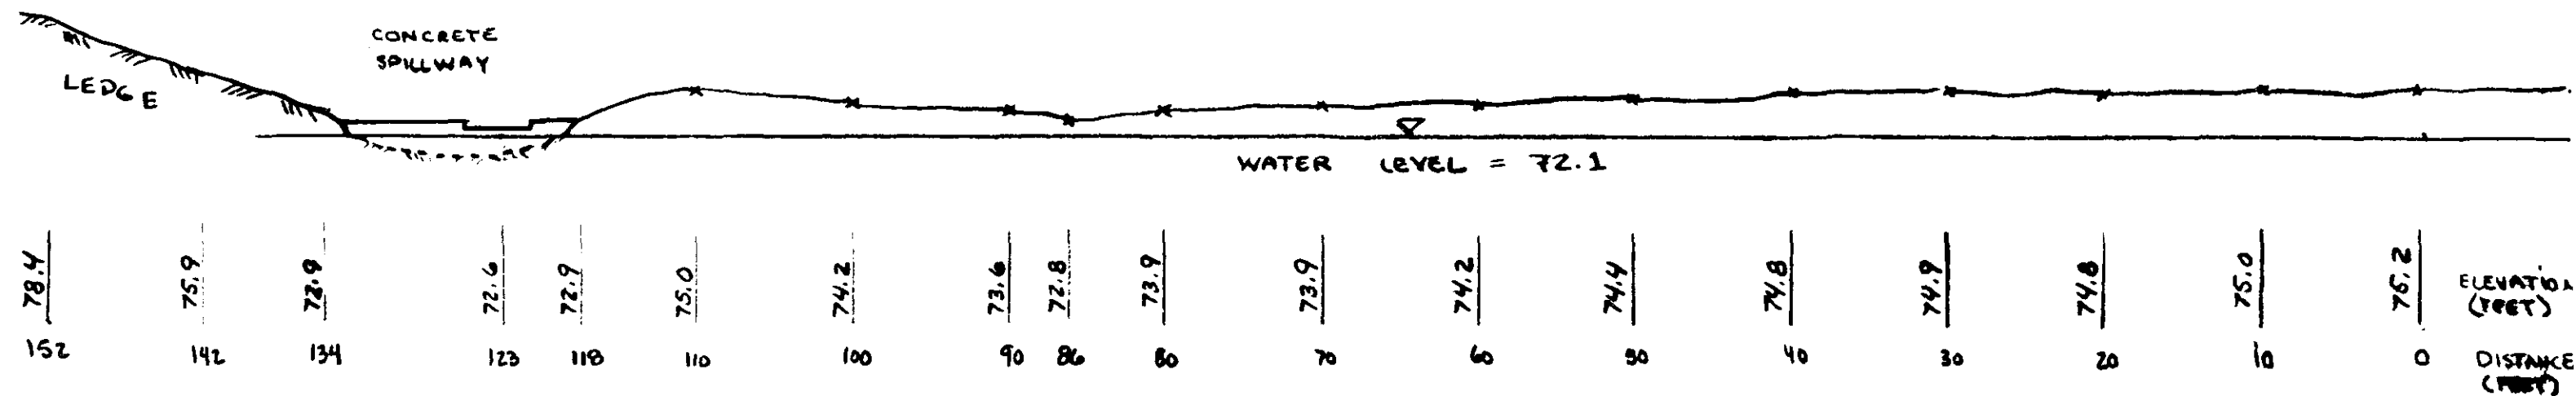
### PROFILE A-A

DAM CREST

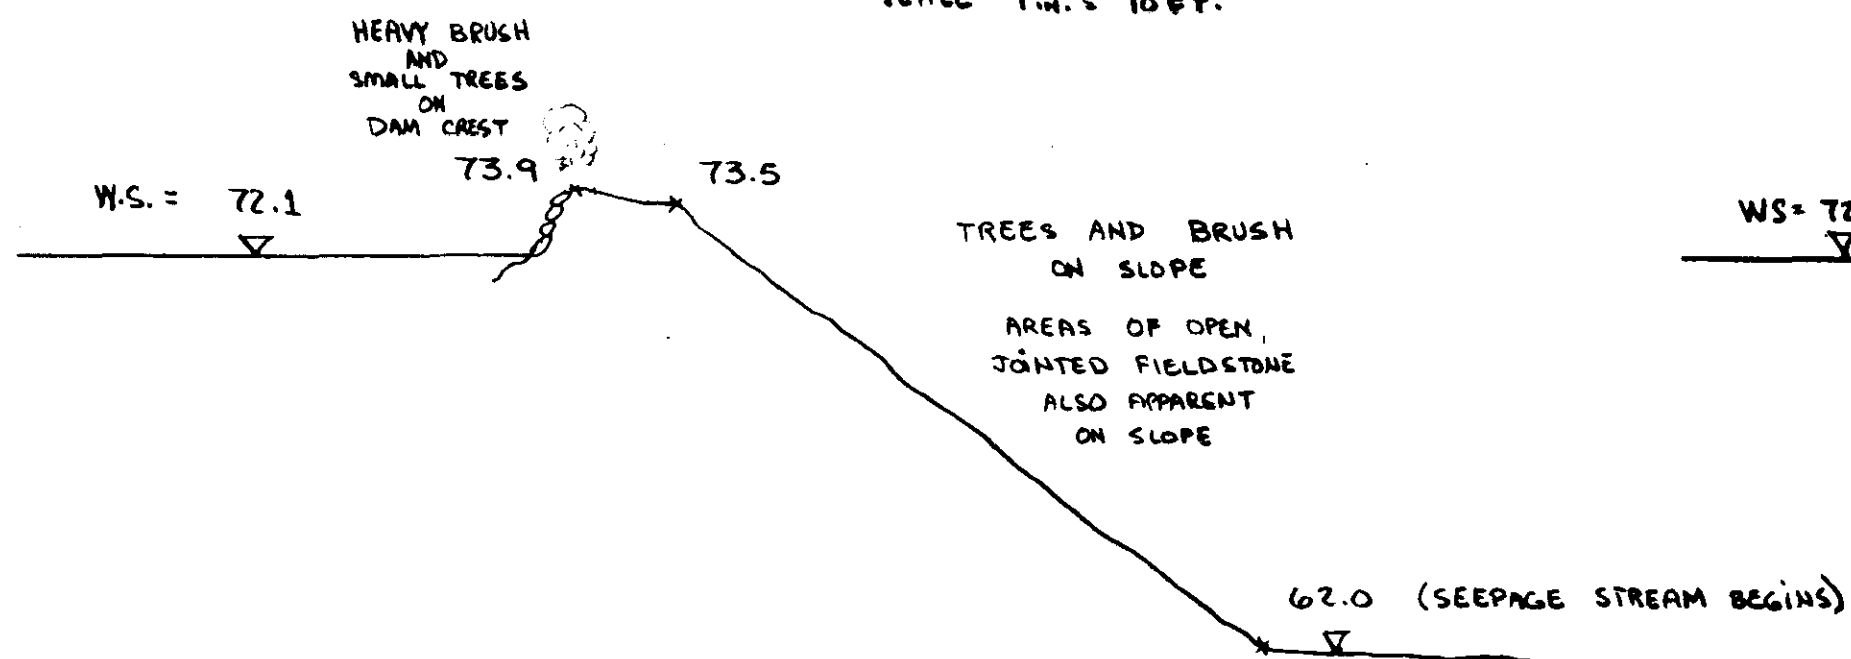
### SECTION 1-1

DAM EMBANKMENT

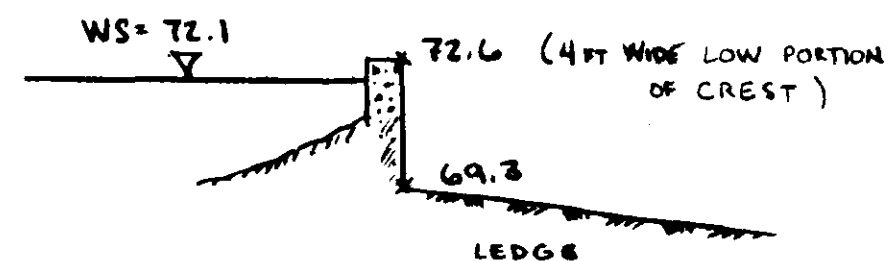
### SECTION 2-2

spillway. A rectangular notch, centrally located in the spillway, is 4.0 feet long, 0.3 feet deep and is at El 72.6. The crest of the main weir is at El 72.9. The spillway is constructed of mortared stone capped with concrete and is generally in poor condition. The mortar and stone are cracked, spalled, stained, and partially eroded. The spillway and training wall have separated and water is flowing through the separation (see photograph 7 in Appendix C). Water is also seeping through the spillway stonework. The eastern end of the spillway is founded on a rock outcrop, and water is flowing between the concrete and the rock (see photograph 6 in Appendix C). The outcrop serves as the floor of the spillway as well as the eastern training wall (see photograph 5 in Appendix C). The training wall on the western side of the spillway is constructed of concrete and tapers from a height of 2 feet at the weir to ground level approximately 15 feet downstream.

- 4.3 Maintenance of Operating Facilities. The spillway is not maintained. The weir is cracked and eroded and water is seeping through both ends of the weir.

SPILLWAY
